▶ DEWEK 2017

Bearing Lifetime Optimization with Ceramic Greases

Dr. Holger Streetz • Bathan AG

Session #16 Lifetime Extension / O & M

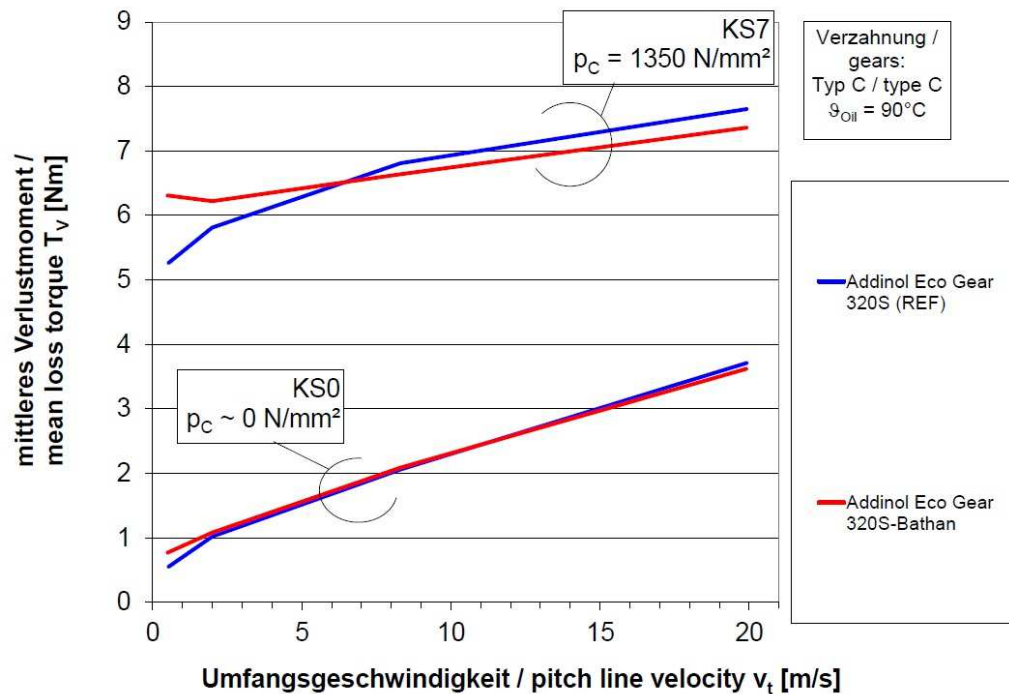
Analyses at the Institute of Machine Elements at TU Munich show up to 9 % lower power losses and 1,5 % lower cumulated mean loss torque.

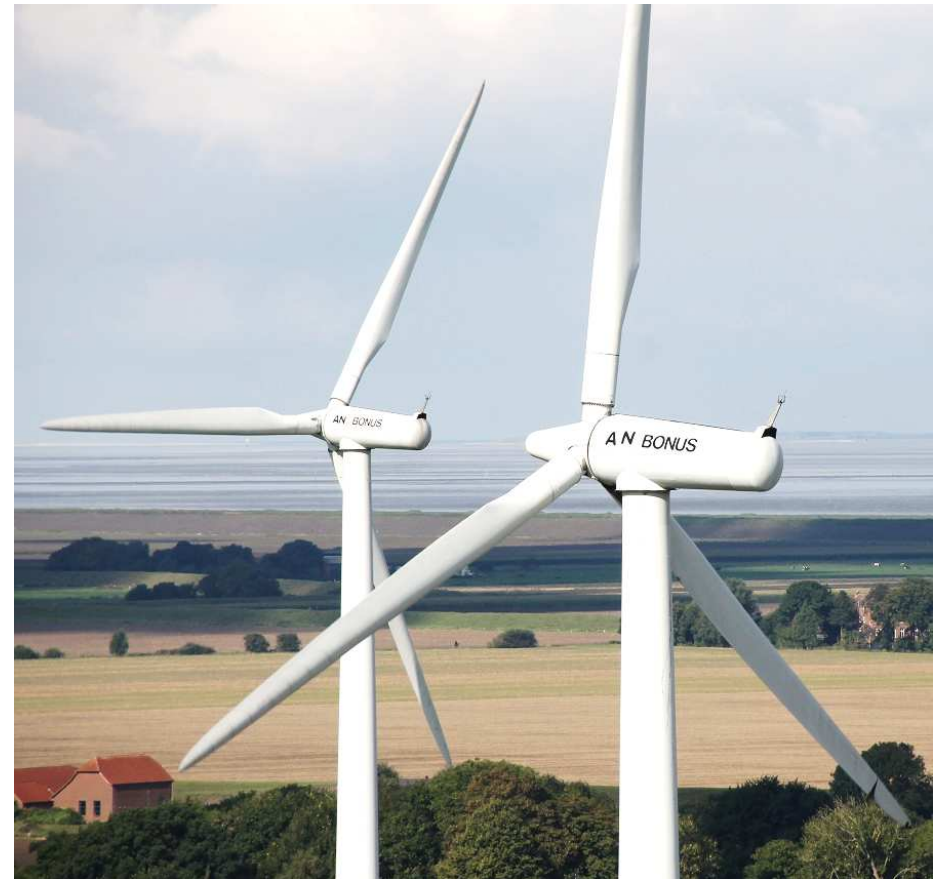
The analysis objects for the long-term study are AN Bonus (Siemens) wind turbines

- Nominal capacity: 600 / 1.300 kW
- On/Nom./Off speed: 3 / 15 / 25 m/s
- Rotor: 44 m, 3 blades
- Gear: Spur / Planetary
- Generator: asynchronous, 1500 U/min.

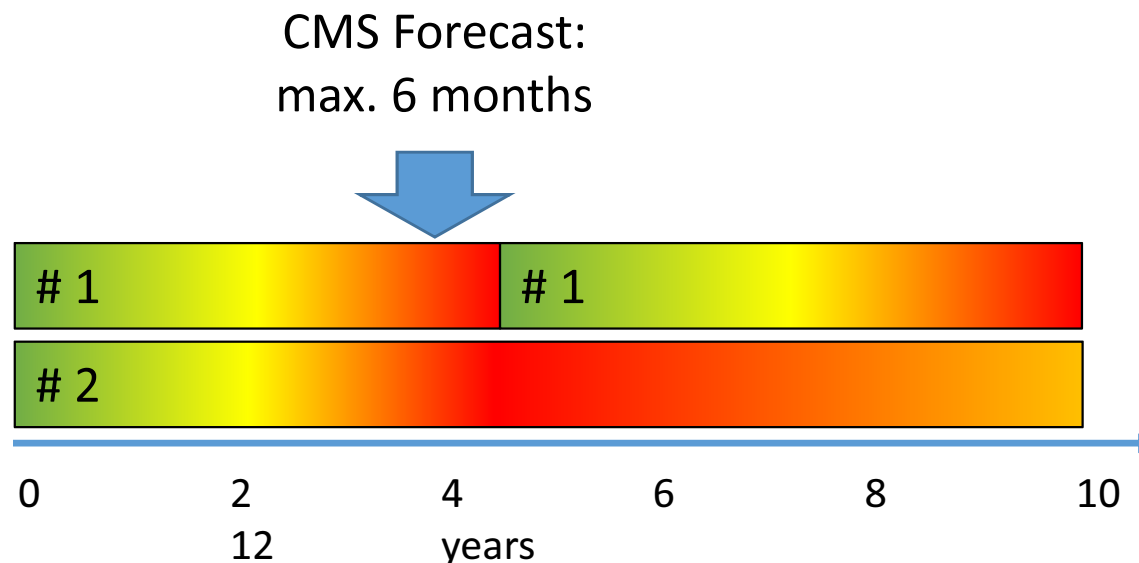
3.1 AN Bonus 600 MK4

Two wind turbines with comparable wear degree of main bearings:

1: Main bearing had to be changed (blocked shaft)

2: Lubrication with Bathan KF7 grease and 400 g every 6 months

2: Bearing condition did not worsen, but still in operation without failure

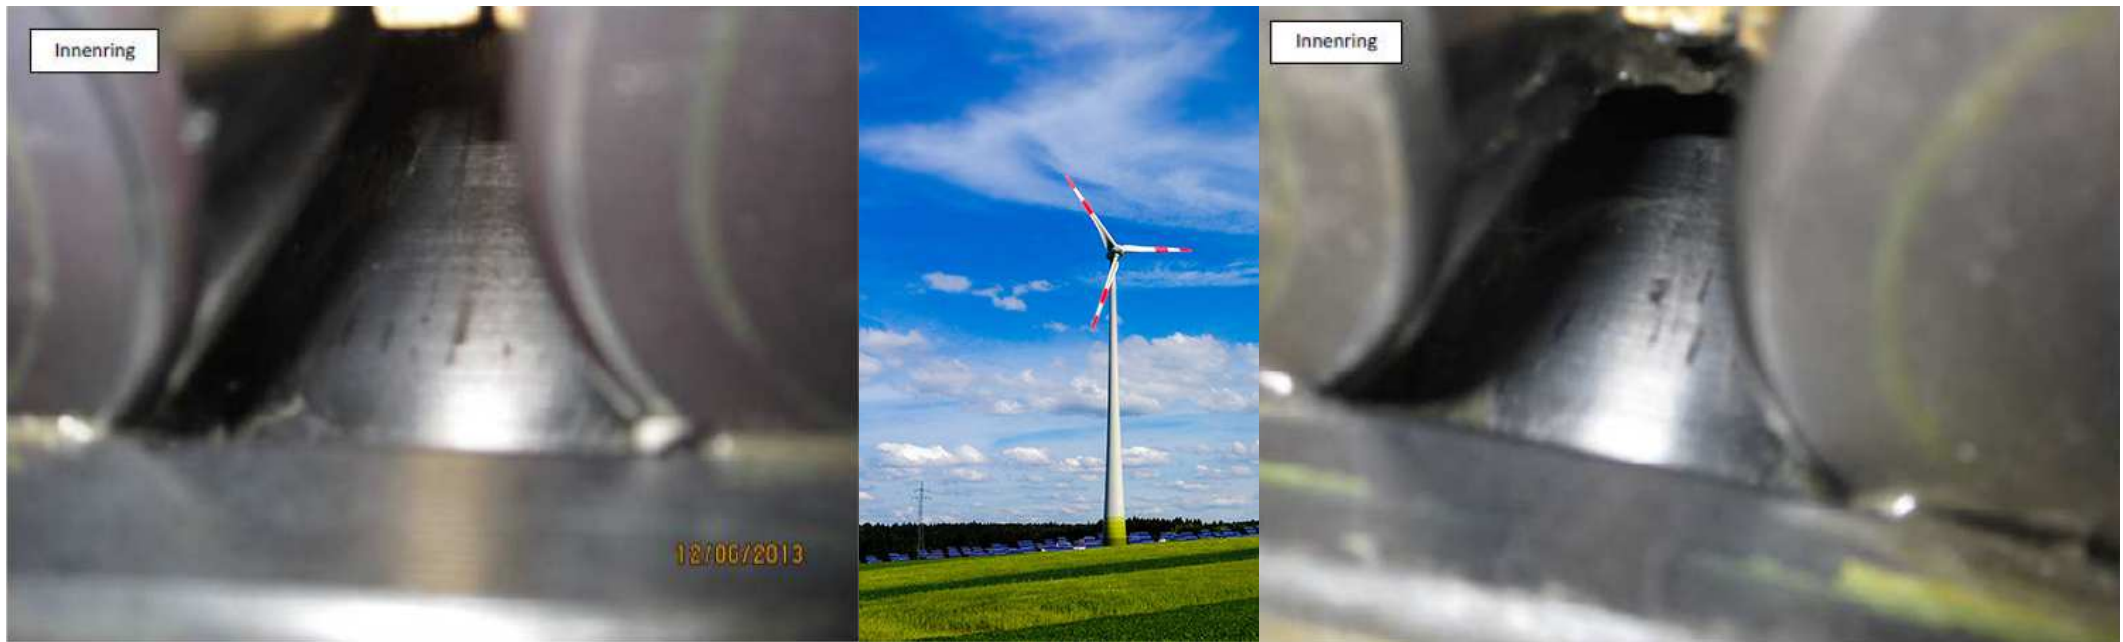
3.2 AN Bonus 1.3 MW

- Objects: 3 wind turbines AN Bonus 1.3 MW
- Problem: September 2013 imminent main bearing failure
- Solution: Lubrication with Bathan KF7 / 60M
- Result: Bearing condition improved
Bearings are operating in their fourth year after 2013

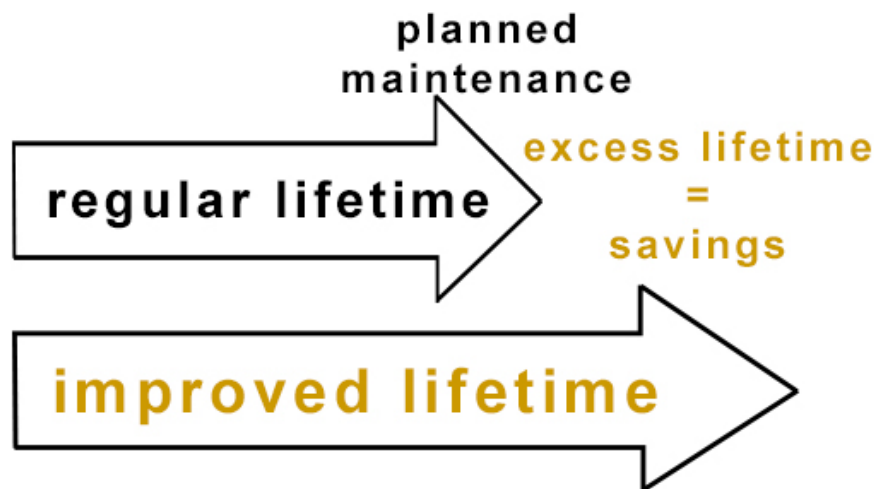
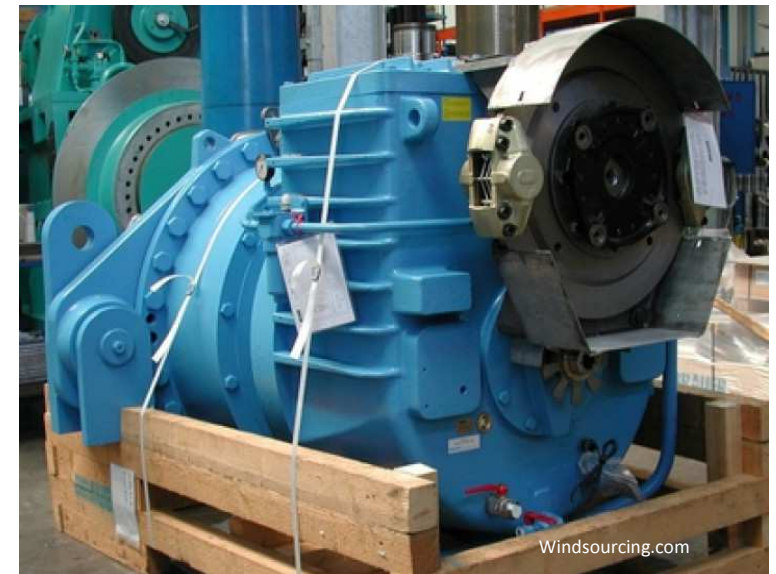
3.3 Flender AN Bonus 600

Object: Flender gear of AN Bonus 600 wind turbine, built 1990

Problem: High wear (PQ index at 140)

Solution: Bathan Additive for Gears in 2013

Result: Gear was not changed; PQ Index at 37
Wind turbine is operating in its fourth year

Side effect: Viscosity at 40°C from 310 to ≤ 290 mm²/s
